**DEPARTMENT OF TRANSPORTATION****DIVISION OF ENGINEERING SERVICES**

Contract #: 04-0120F4Cty: SF/ALA Rte: 80 PM: 13.2/13.9File #: 69.28**WELDING INSPECTION REPORT****Resident Engineer:**Pursell, Gary**Address:** 333 Burma Road**City:** Oakland, CA 94607**Report No:** WIR-004231**Date Inspected:** 07-Oct-2008**Project Name:** SAS Superstructure**OSM Arrival Time:** 1430**Prime Contractor:** American Bridge/Fluor Enterprises, a JV**OSM Departure Time:** 2030**Contractor:** Zhenhua Port Machinery Company, Ltd (ZPMC), Changxing Island **Location:** Shanghai, China

# WELDING INSPECTION REPORT

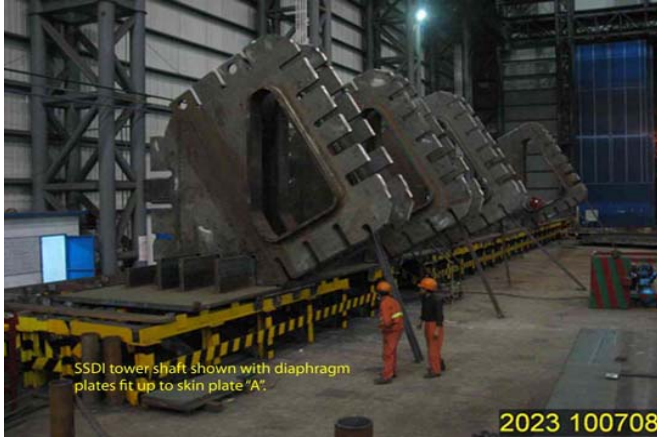
Tower Bay 1: QA Inspector performed random visual inspection of SSDI Skin "A" stiffener to skin plate welds between elevation 0 and 38 meters for green tag. QA Inspector identified seven areas that require rework/repair. The welds between elevation 38 meters and 48.6 meters will be inspected by the third shift QA Inspectors. ABF representative Mr. Don Walton informed the QA Inspector that several of the weld relief areas at approximately 30 meter elevation require welding that will take place tomorrow.
